REPORT OF INVESTIGATION AND MITIGATION OF SOIL
CONTAMINATION ENCOUNTERED DURING GRADING
OPERATIONS AT NURSERY SUPPLIES, INC.,
CITY OF ORANGE, CALIFORNIA

July 1, 1986

Project No. 2850974-05

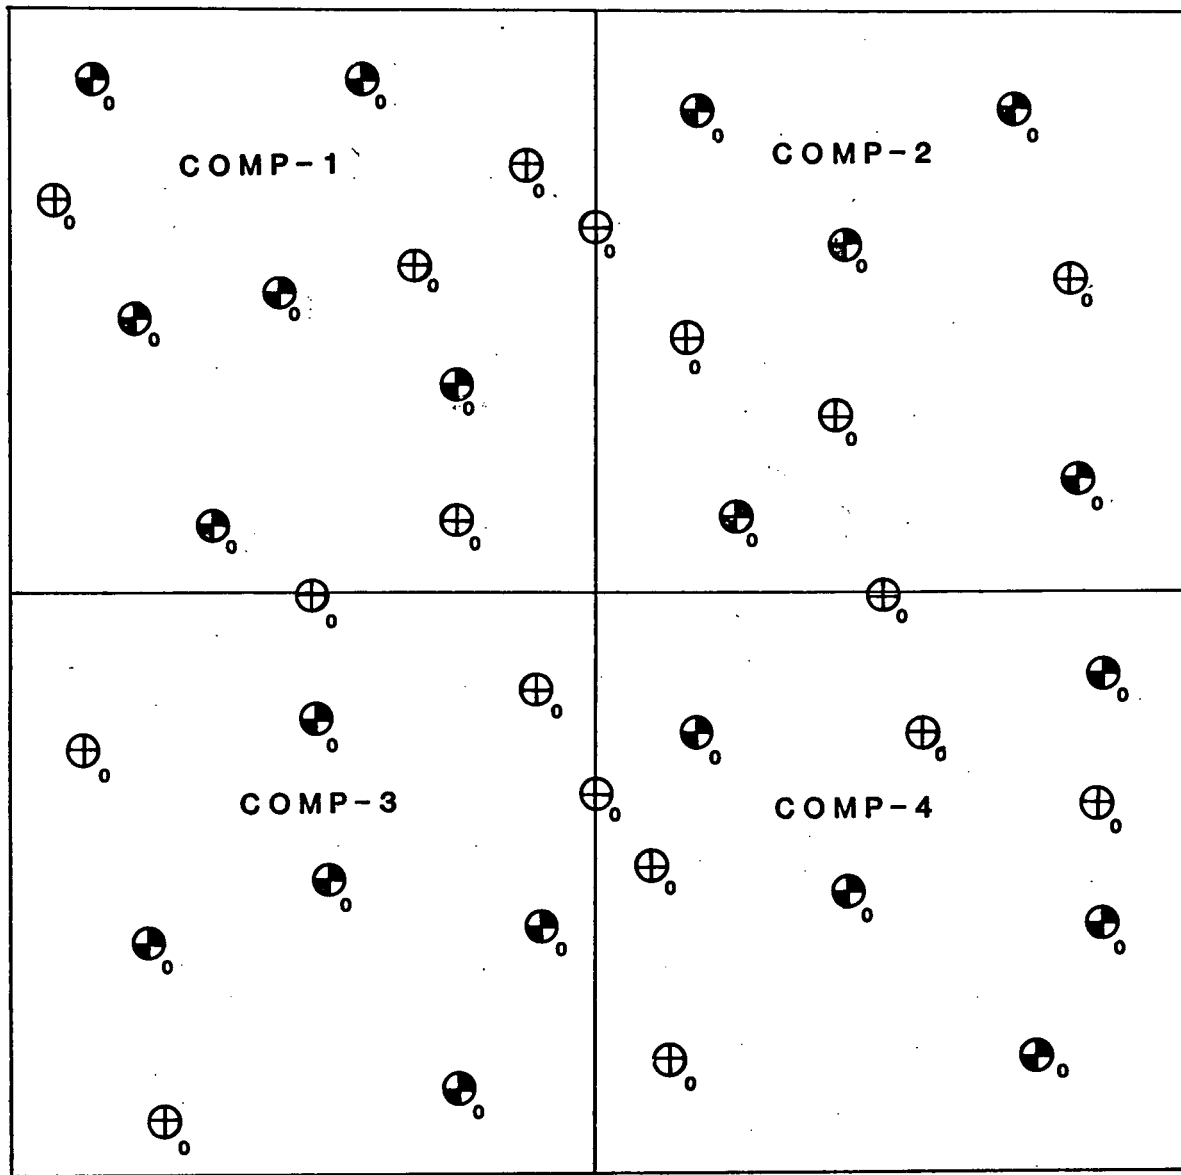
PLATE 2

On November 15 and 18, 1985, composite soil samples were collected from the aerated soil. No contamination was detected with the PID. Composite samples were also collected from the underlying natural soil. Locations of composite samples are shown on Plate 2. Test results for all composite samples were none detected, less than 0.2 ppm for styrene and none detected, less than 0.1 ppm for ethyl benzene.

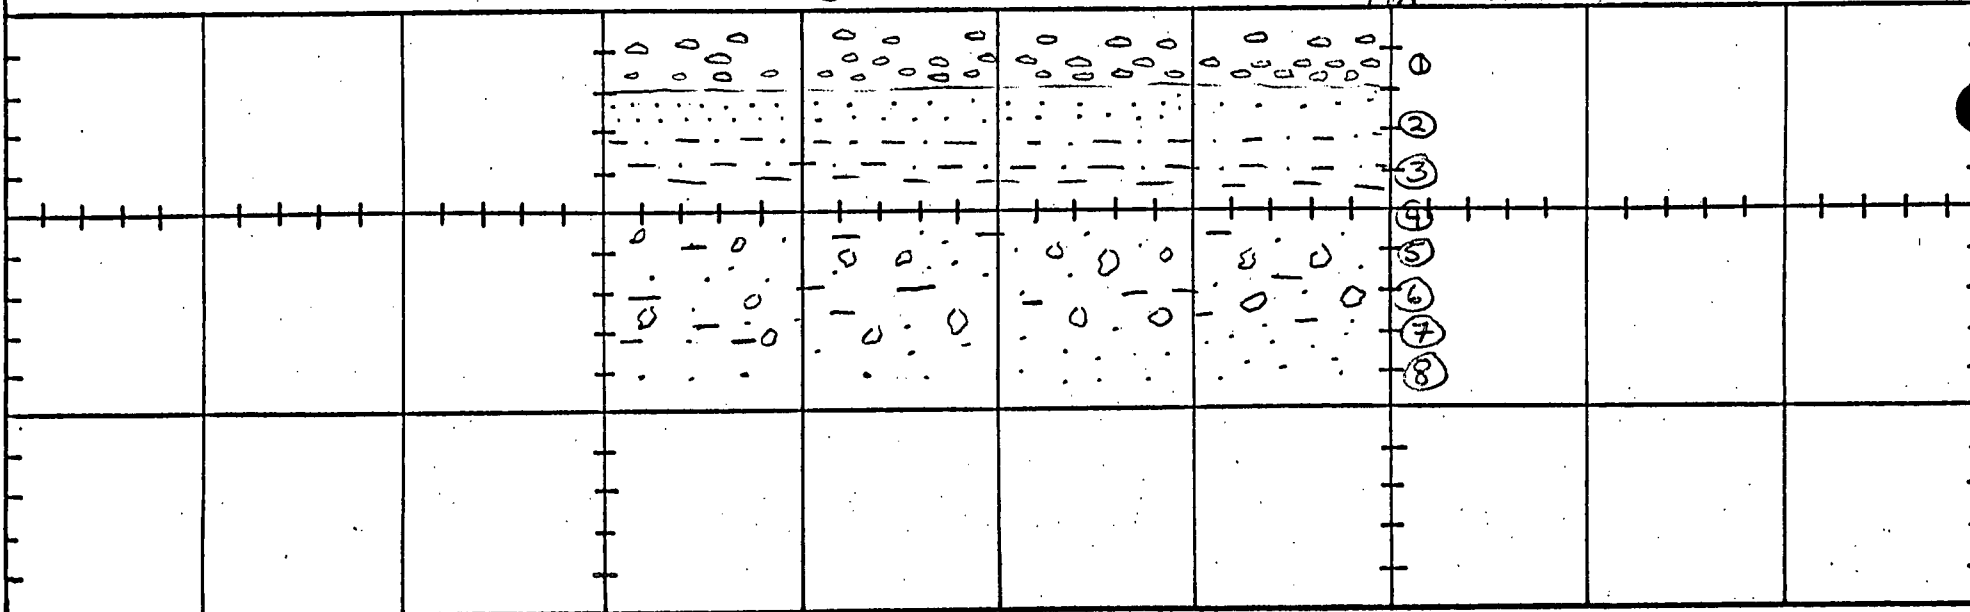
GEOLOGIC ATTITUDES PID	DATE: 9-19-85	DESCRIPTION:	GEOLOGIC UNIT	U.S.C.S.	Sample No.	P.L.D.	Density (pcf)
	0-2	Railroad Ballast			1 @ 1'	300	
	2-3	Fine to coarse sand			2 @ 2 1/2'	30	
	3-4.5	Red Clay			3 @ 3'	10	
	4.5-8	Gravelly, Clayey fine to coarse sand with some cobbles.			4 @ 4'	10	
					5 @ 5'	6	
					6 @ 6'	1	
					7 @ 7'	0	
					8 @ 8'	0

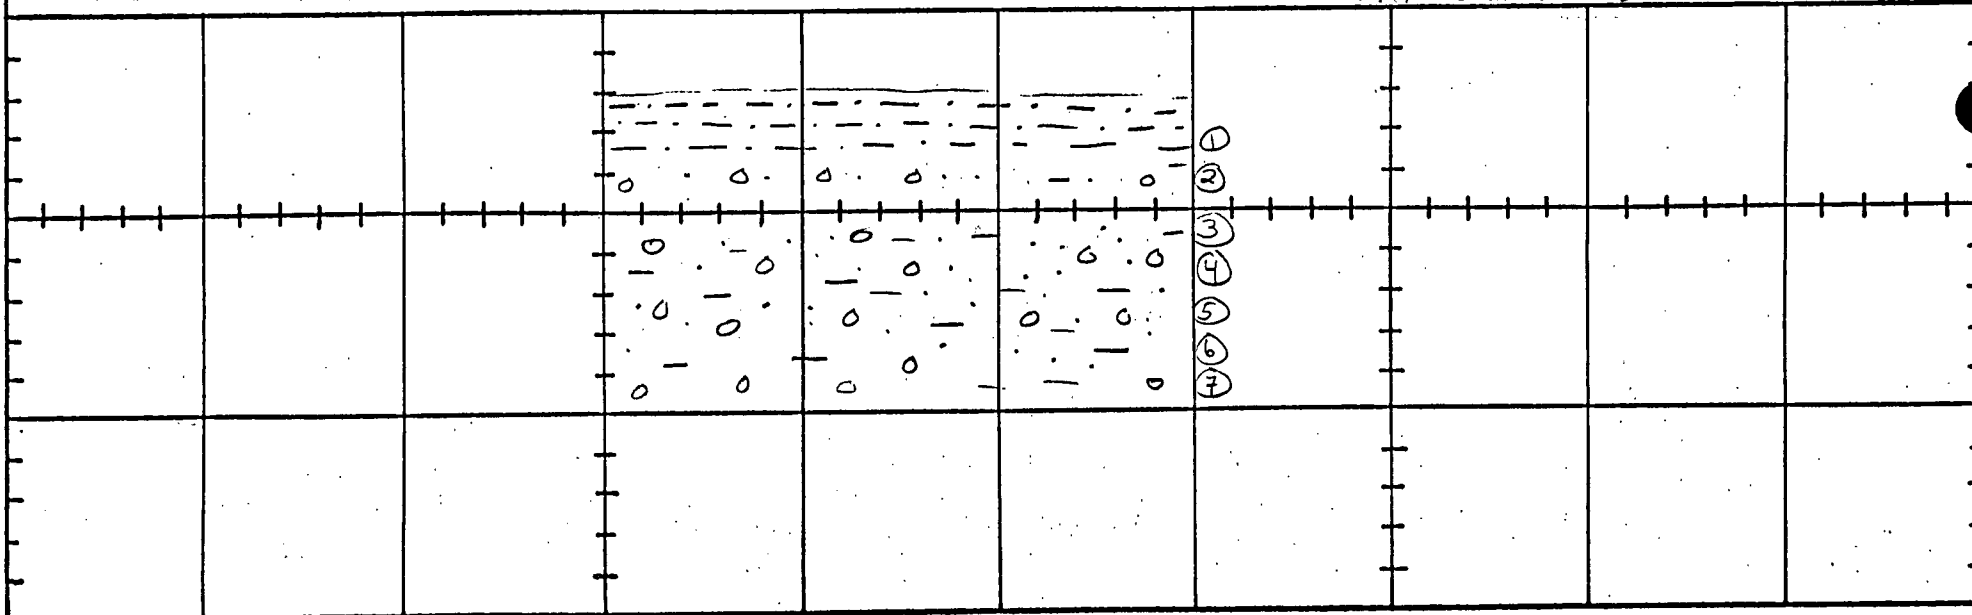
LOG OF TRENCH NO. T-1

GEOLOGIC ATTITUDES	DATE: <u>9-19-85</u>	DESCRIPTION:	GEOLOGIC UNIT	U.S.C.S.	Sample No.	P.I.D.	Density (pcf)
	<u>0 - 1 1/2'</u>	<u>Red clay</u>			<u>1 @ 1'</u>	<u>5</u>	
	<u>1 1/2' - 8'</u>	<u>Gravelly, clayey fine to coarse sand with some cobbles, moist, reddish brown.</u>			<u>2 @ 2'</u>	<u>5</u>	
					<u>3 @ 3'</u>	<u>5</u>	
					<u>4 @ 4'</u>	<u>1</u>	
					<u>5 @ 5'</u>	<u>0</u>	
					<u>6 @ 6'</u>	<u>0</u>	
					<u>7 @ 7'</u>	<u>0</u>

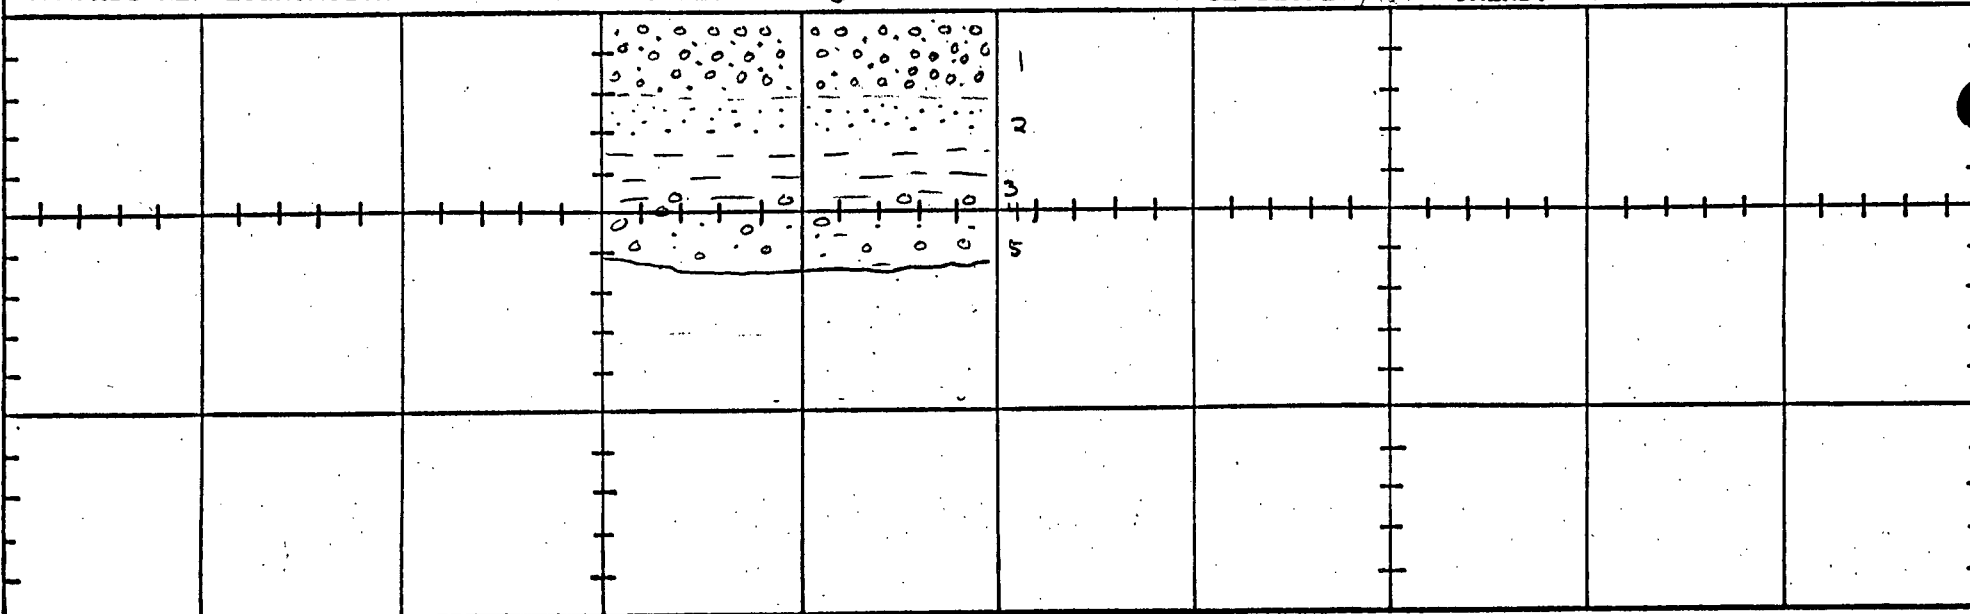
LOG OF TRENCH NO: T-2

GEOLOGIC ATTITUDES	DATE: <u>9-19-85</u>	DESCRIPTION:	GEOLOGIC UNIT	U.S.C.S.	Sample No.	P.I.D.	Density (pcf)
	0-2	Railroad Ballast			1 @ 1'	60	
	2-3	Fine to coarse sand, damp, Gray-Yellow			2 @ 2 1/2'	25	
	3-4 1/2	Red clay			3 @ 4'	8	
	4 1/2 - 6	Gravelly, Fine to coarse sand, with some cobbles, moist, Reddish Brown.			4 @ 5'	1	
					5 @ 6'	0

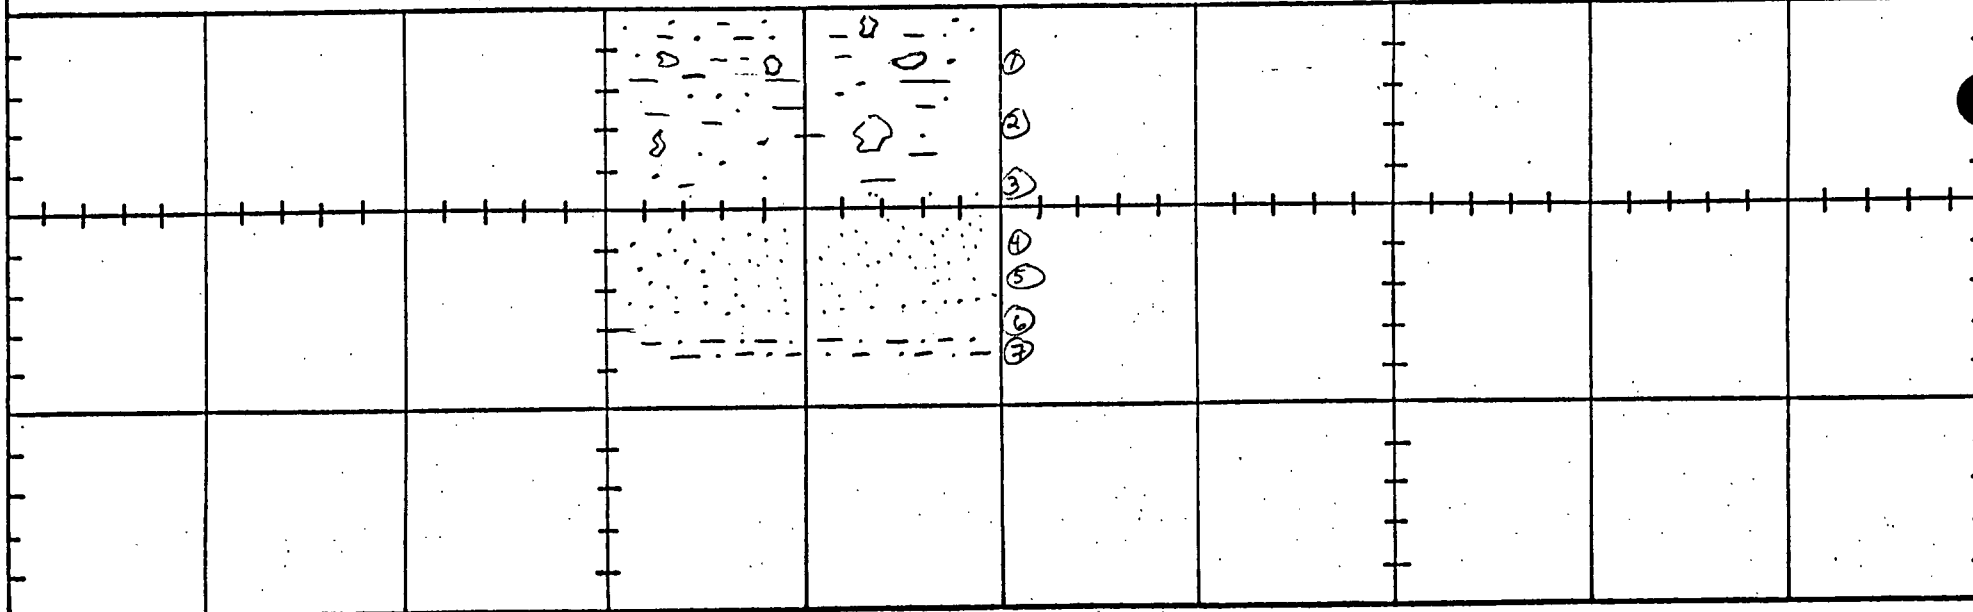
LOG OF TRENCH NO. T-3

GEOLOGIC ATTITUDES	DATE:	DESCRIPTION:	GEOLOGIC UNIT	U.S.C.S.	Sample No.	Moisture (%)	Density (pcf)
		0-10' Fill material, Dark to Olive Green, damp, clayey sand with gravel, concrete debris, wood debris, pipes.			1@3'	0	
					2@6	0	
					3@9	0	
					4@12	0	
					5@15	0	
		10-16' Tan, moist, silty v. fine to coarse sand,			6@17	0	
					7@18.5'	0	
		16'-18.5' Reddish Brown, moist, silty clay. roots.

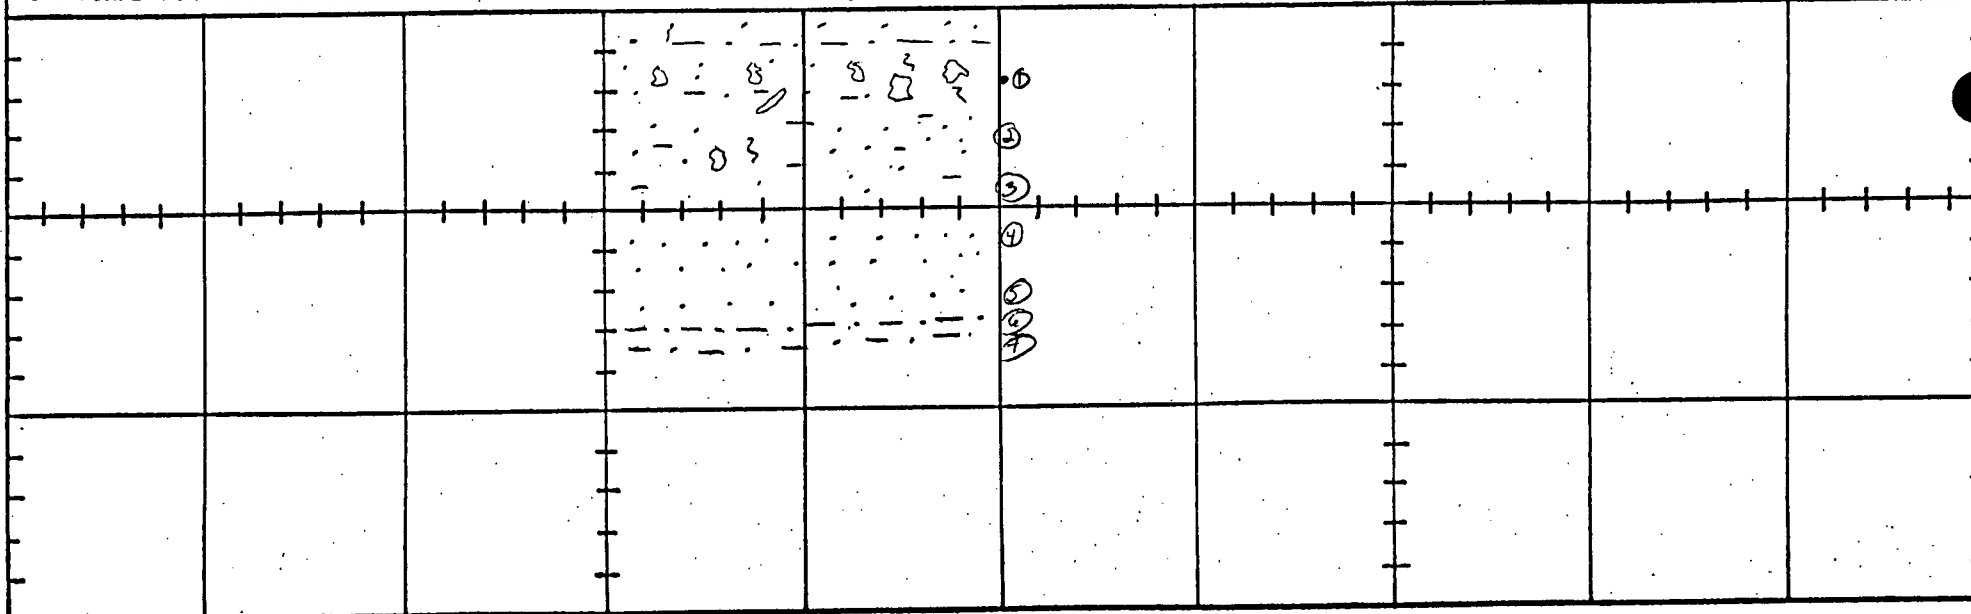
GEOLOGIC ATTITUDES	DATE:	DESCRIPTION:	GEOLOGIC UNIT	U.S.C.S.	Sample No.	Moisture (%)	Density (pcf)
		0-10' Fill material, Dark to olive green, damp, clayey sand with gravel, concrete debris, wood debris, pipes.			1 @ 2.5'	0	
					2 @ 6'	0	
					3 @ 9'	0	
					4 @ 12'	0	
					5 @ 15'	0	
		10-16' Tan, moist, silty v. fine to coarse sand.			6 @ 16'	0	
					7 @ 17'	0	
		16-17.5' Reddish brown, damp, silty clay, roots
